Machinery Messages

Case History

A tale of two motors

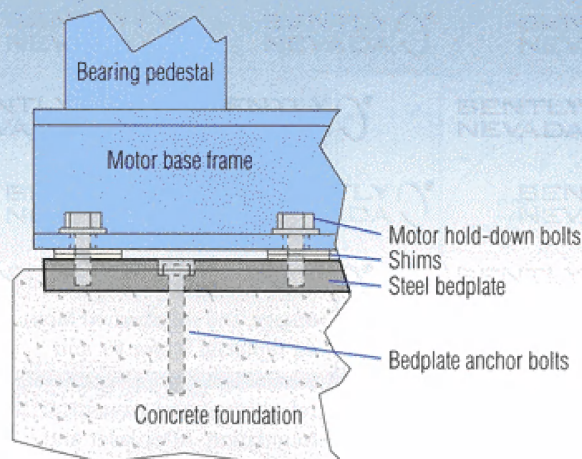
All of the motor's seals were inspected for evidence of a stationary part rub. The primary frequency component of 1X could have been evidence of a thermal bow induced by a light rub. No evidence of seal rubs was discovered, and examination of the motor foundation revealed an unusual support structure for a machine this large (Figure 2). The motor base frame was only supported by 4 x 4 inch shims under each hold-down bolt, and the space between the foundation bedplate

Figure 2. Mounting detail of original motor foundation. Frame supported only by shims and not grouted to bedplate.

and the frame was not grouted. To increase the support stiffness, and as a temporary solution until a better foundation modification could be implemented, double-tapered wedges were driven between the motor frame and the foundation bedplates at several locations. The hold-down bolts were re-torqued. The immediate effect this increase in the foundation stiffness had on the operational amplitudes was to reduce the 1X vibration amplitudes by over 50% (Figure 3). A foundation upgrade was planned for the 1996 outage, and the wedges were re-tightened several times during the year when the 1X vibration amplitudes began to increase.

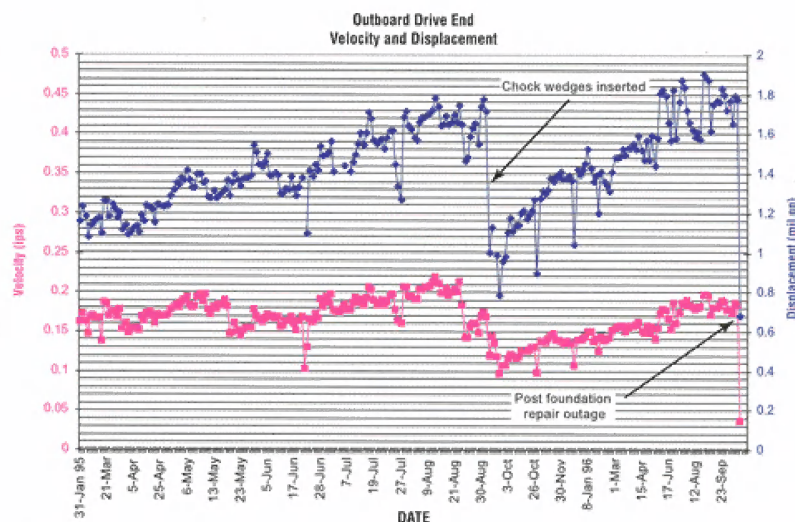
Figure 3. Effect of increased mounting stiffness on shaft relative (displacement) and housing (velocity) vibration.

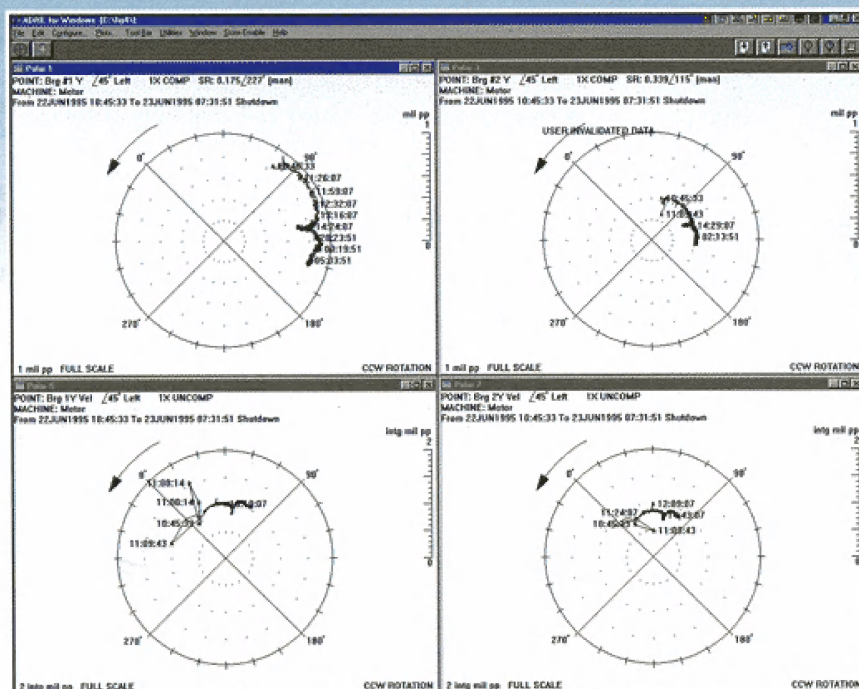
In the summer of 1995, the unit was shut down because of a hurricane in the area. Transient data was acquired during the outage to check for further evidence of shaft cracking and to determine if the temporary wedges needed re-tightening. Shortly after startup, transient and steady state data revealed an alarming change in the slow roll vector and a large shift in the 1X phase (both are possible indicators of shaft cracking). However, data sampled during the next two days, as the compressor was loaded to full capacity and the motor current increased to maximum, indicated a large thermal vector change in the rotor response (Figure 4). Although amplitudes remained fairly consis-

tent, the 1X phase shifted over 90° on both bearings. As the rotor temperatures stabilized, the 1X amplitudes and phases trended back to levels recorded prior to the shutdown. The rotor contained a very large, previously unknown thermal vector. This thermal vector was responsible for the difference in the slow roll values, as well as the difference in the 1X amplitude and phase from hot to cold.

Figure 4. Motor #1 thermal vector change in rotor response over 21 hours as compressor was loaded to full capacity.

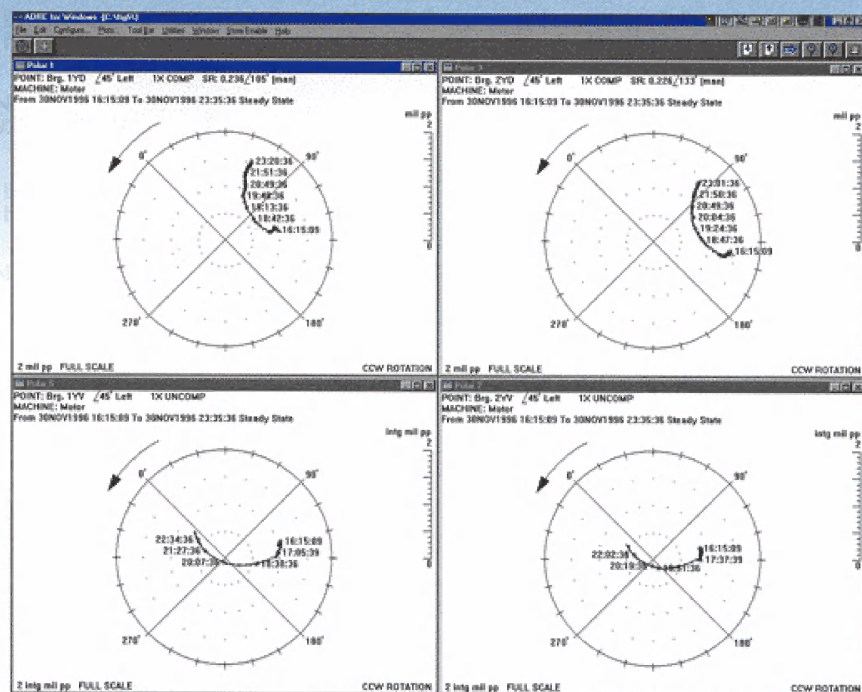
Figure 5. Motor #2 thermal vector change in rotor response during part of heat soak cycle at full load.

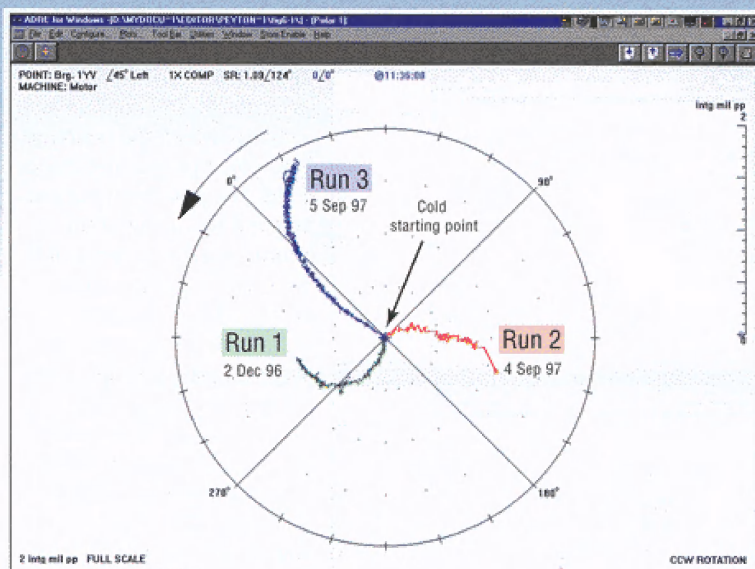
Figure 6 shows a comparison of three heat soak runs on Motor #2 on 2 December, 1996 and 4 and 5 September, 1997. For clarity, the initial cold starting point of the thermal vector has been moved to the center of the polar plot. As you can see, the magnitude and direction of the vector was not repeatable. The runs on 2 December and 4 September are with no change to the balance condition. The run on 5 September was an

attempt to balance the 4 September thermal vector. This proved to be an impossible trim balancing problem. Although the rotor responded well to initial balance weights, and the balance influence data was consistent, the changing direction and length of the heat soak thermal vector made the operational amplitude and phase unpredictable.

Figure 6. Motor #2 thermal vector changes. Run 1 and run 2 are with no change in balance condition. Run 3 shows results of trim balancing attempt using run 2 data.

The inability to balance the rotor, and concerns of a possible rotor crack, loose windings, or unknown electrical problem, led plant personnel to the correct decision to replace Motor #2 with Motor #1. The thermal vector in Motor #1 was trim balanced, and the unit is in operation. However, there are indications of a slight upward trend in vibration amplitude which plant personnel are monitoring very closely. Motor #2 was returned to the OEM for evaluation and repair. Seven heat soak runs on the OEM test floor produced the thermal vectors shown in Figure 7. Again, for clarity, the initial cold starting point of the thermal vector has been moved to the center of the plot.

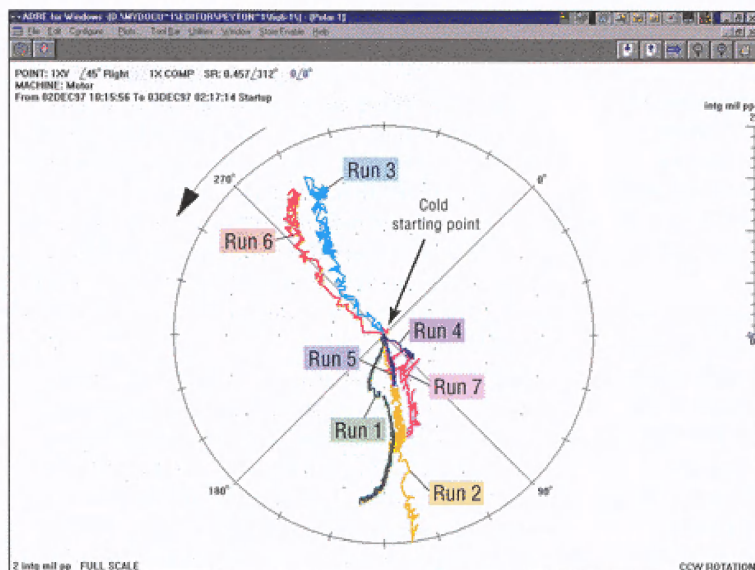
Most thermally-sensitive rotors are very predictable, well-behaved units that have straightforward root causes for their behavior. The fact that the magnitude and direction of the vector were not repeatable was extremely unusual. Teardown of the motor revealed

loose copper windings on all four poles. Jacking bolts on the end turns of one pole were loose, and cracked insulation between the windings and pole tips was also discovered. The post overhaul testing and balancing of the motor returned a repeatable thermal vector and a predictable balance response. While the exact cause of the large thermal sensitivity and its lack of repeatability remain unknown, loose windings are suspected to be the most likely cause. Differential tightness of each pole winding set will produce differential axial strain on the rotor as the windings expand axially.

Figure 7. Motor #2 thermal vector changes from seven heat soak runs performed on OEM test floor.
